# Manhole Inspection Summary

Manhole # S19I1\_024MH

Insp Date: **4/22/08 12:19 PM**

**Location** Address: **3036 huron st**

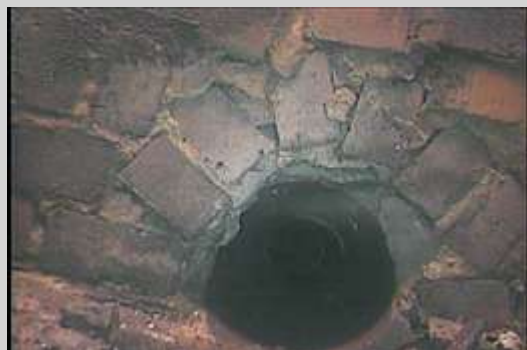
12 O'Clock Outflow

8 in. Circular Gravity Sewer  
Pipe Out @ 12 O'Clock

Infiltration: **None** Pipe Seal Cond: **Sound**
